STATE LEVEL ENVIRONMENT IMPACT ASSESSMENT AUTHORITY - TAMIL NADU

Inspection Report of the Committee constituted as per the Hon'ble National Green Tribunal (PB) order dated 26.02.2021 in O.A. No. 360 of 2015 – Sand Quarry in Palar River at SF No. 1588(P) Sakkaramallur Village, Arcot Taluk, Ranipet District

AUGUST 2025

Date of Inspection 20.08.2025

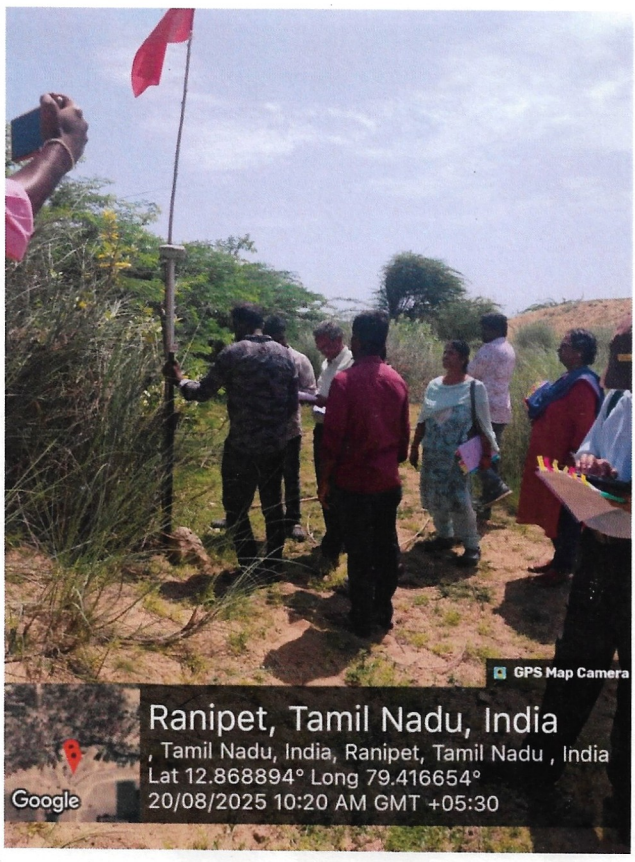
7. A temporary bench mark (TBM) was transferred from a permanent mark from the Palar Anicut. But the Proponent has not provided TBM with pillar for referring Mean Sea Level (MSL) at the site. However, during inspection they have shown Bench mark reference point marked near electric post on southern bank. From this point, MSL were transferred to the site. The latitude and longitude of the four corners were measured using Differential Global Positioning System (DGPS) instrument. The measured values are given below.

Measuring at Temporary Bench Mark Reference Point

4. The Project Proponent shall construct and maintain a permanent bench mark concrete pillar at the mining site, clearly indicating the bench mark level with reference to Mean Sea Level (MSL), for monitoring of mining depth and compliance. Photograph shall be submitted before commencement of mining.
